# ELIZABETH MINE

You are standing at the center of the Elizabeth Copper Mine site, a scene of widespread industrial activity from 1809 to 1958. The mine was the largest producer of the chemical "copperas" in the United States in the mid-nineteenth century. Modernized for World War II production, it became one of the top 20 American copper ore producers of the 1950s. A century and a half of mining left behind a dramatic landscape of mining waste that contaminated part of the Connecticut River watershed. The U.S. Environmental Protection Agency declared the Elizabeth Mine a "Superfund" site in 2001, and the EPA's cleanup actions have dramatically improved the ecological health of the impacted streams and rivers.

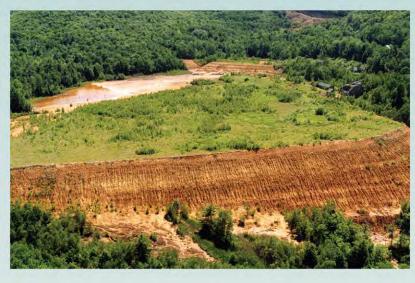
Aerial view of partially overgrown Elizabeth Mine copper ore mill waste tailings pile looking southwest, 1990s. Source: Strafford Historical Society.

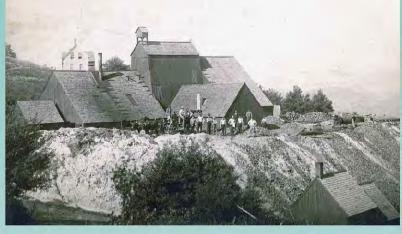
Tyson Shaft No. 1, 1880s. Buildings housed steam engine, hoist, and ore crusher. Source: Collamer Abbott Collection, University of Vermont.

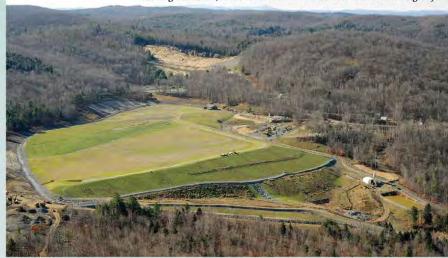
Cleared and preserved World War II copper ore mill foundations, with completed mine waste storage area visible beyond. Source: U.S. Environmental Protection Agency.

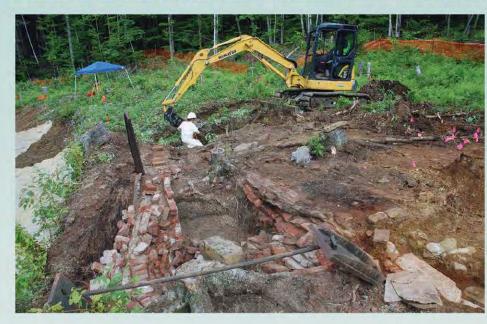
Archaeologists digging with hand tools and a small backhoe documented the workings of the copperas factories as part of the site cleanup. The brick pit in foreground is part of a copperas cooling and settling vessel found at the lower factory in 2009. Source: U.S. Environmental Protection Agency.

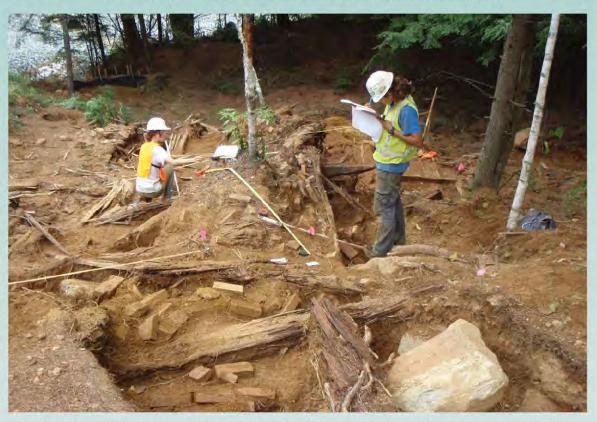
Archaeologists found well-preserved stone, metal, and wood remains of the three main boiling, cooling/settling, and crystallizing steps of copperas production, which closely matched nineteenth-century written accounts of the Copperas Hill factories. Here archaeologists measure and draw the remains of brick-lined copperas vessels and a network of support timbers at the upper copperas factory, 2010. Source: U.S. Environmental Protection Agency.

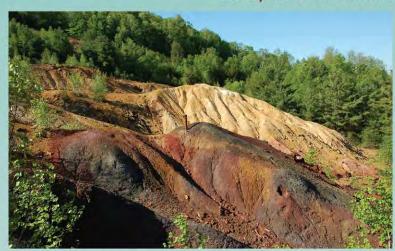
Weathered dark copperas ore in piles from roasting and heap leaching and lighter copper mining waste rock on Copperas Hill before the cleanup, 2010. Source: U.S. Environmental Protection Agency.

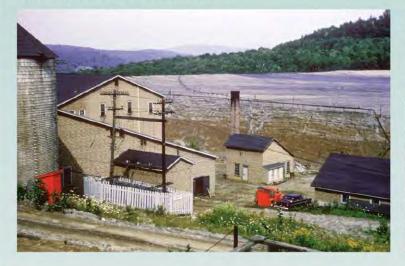
World War II-era copper ore storage silo and Concentration Mill, with ore mill tailings pile beyond, 1950s. Source: Strafford Historical Society.

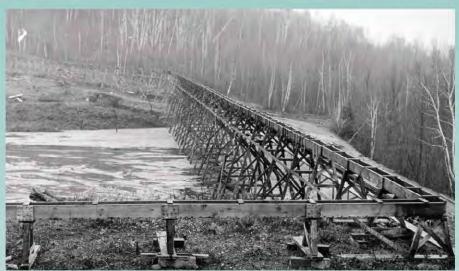
Left: A miner poses with an electric mine locomotive, 1950s. Source: Strafford Historical Society. Below: Elevated wood troughs for pumping copper mill waste onto the tailings pile, 1950s. Source: Strafford Historical Society.
